#### ASSESSING THE ADAPTABILITY OF A RIVER CONTRACT IN THE CATCHMENT AREA OF THE KALAMU RIVER AT BOMA (KONGO CENTRAL, DEMOCRATIC REPUBLIC OF THE CONGO)

This study assesses the feasibility of a river contract scheme for the Kalamu catchment area in Boma. The methodology is based on a literature review, field observations, surveys, and physico-chemical and microbiological analyses of the water. The catchment is under intense anthropogenic pressure, exacerbated by the floods of November 2015 and December 2016, which caused considerable loss of life and property. Whilst the physico-chemical parameters indicate that water quality is generally acceptable for certain uses, the microbiological analyses reveal high levels of contamination by total coliforms, faecal coliforms and *Escherichia coli*, highlighting a major health risk for human consumption. The workshop brought together 82 participants, including local authorities, technical services, civil society, community representatives and key stakeholders. During the participatory workshop, various issues were raised: pollution, bank erosion, silting, deforestation, ecosystem degradation and flood risks. Stakeholders expressed their des

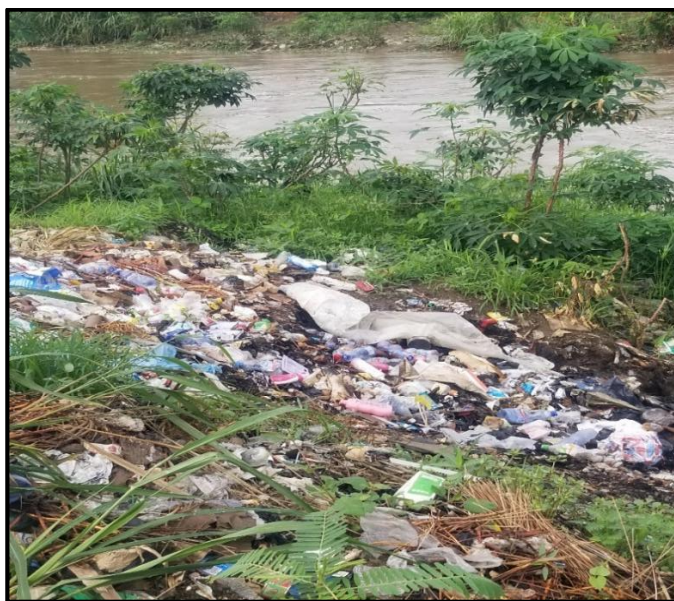
Figure 6. Presence of solid waste along the river.

Waste management is still a serious problem in the town of Boma. Solid waste can be seen all along the arteries and crossroads. Figure 5 shows how waste is disposed of in this town. Out of a total of 384 households surveyed, 43% dumped their waste in rivers, 12% deposited it in the street, 11% composted it, 10% incinerated it on site, 9% deposited it in gutters, 8% buried it on site and 7% deposited it in fields (figures 5 and 6).

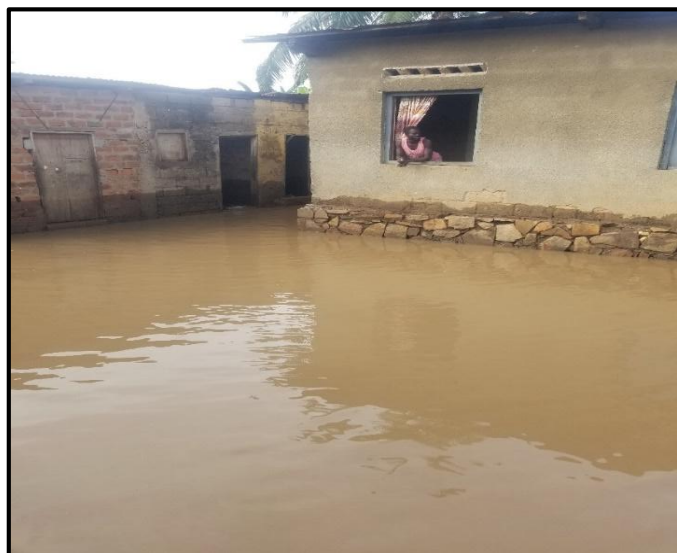
**Figure 9.** House flooded by the waters of the Kalamu river.

The account highlights the high vulnerability of households to flooding in the Kalamu River catchment area in Boma. The event of 10 December 2025 caused significant material losses and temporary displacement. The lack of assistance reveals the limitations of local disaster management. The fact that households remain in the area is mainly due to a lack of financial resources and rehousing options. The willingness of some flood victims to leave the area, with support from the State, highlights the importance of appropriate measures relating to prevention, rehousing and compensation in order to reduce flood-related risks in the long term.
