RESEARCH ARTICLE

DEVELOPMENT AND ANTI-EROSION MEASURES IN URBAN HILLY AREAS: THE CASE STUDY OF KISENKO COMMUNE IN KINSHASA (DR. CONGO)

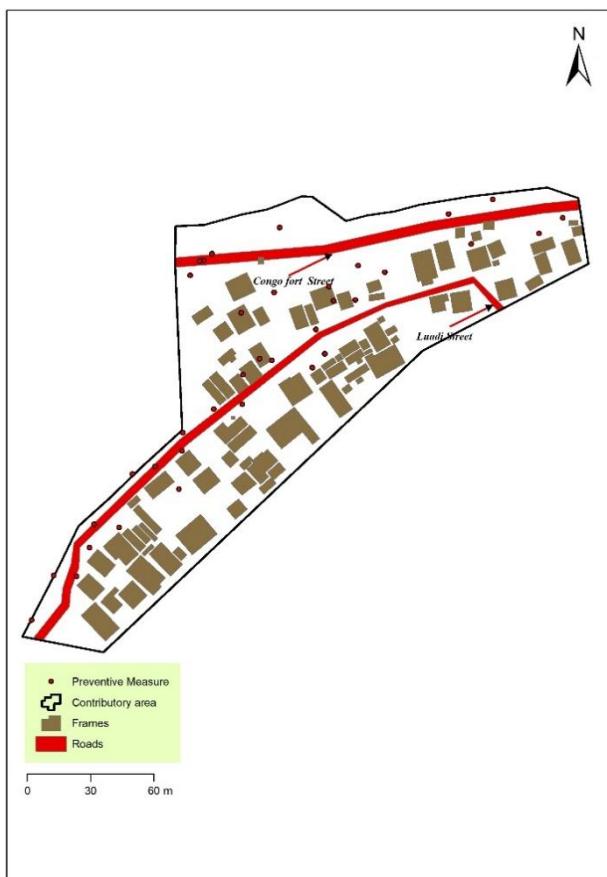
Fig.2a: Location of structures and measures for erosion control in the contributing areas of Congo-Fort

The cartographic results and land use distribution of the contributive zones (CZs) are presented in Figures 2a, b & c, respectively for Congo-Fort, EP5 Livulu, and Madimba.

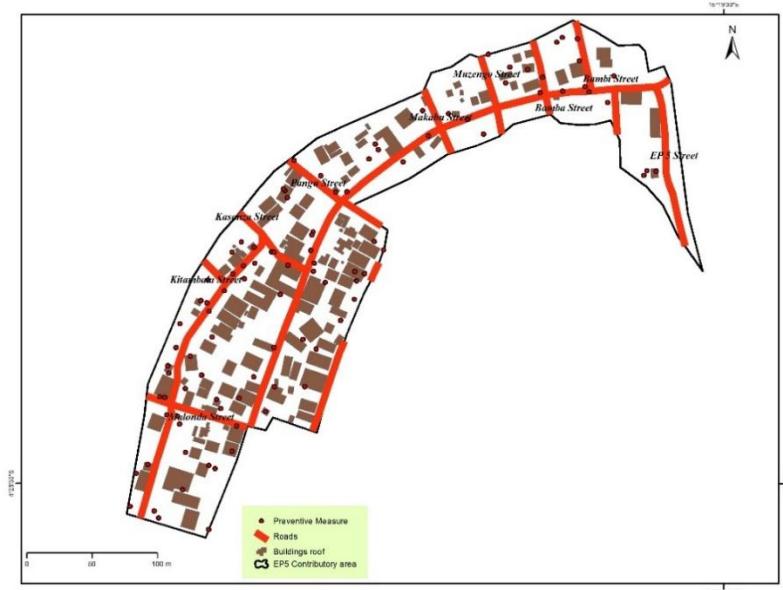
Fig.2b: Location of structures and measures for erosion control in the contributing areas of EP5 Livulu

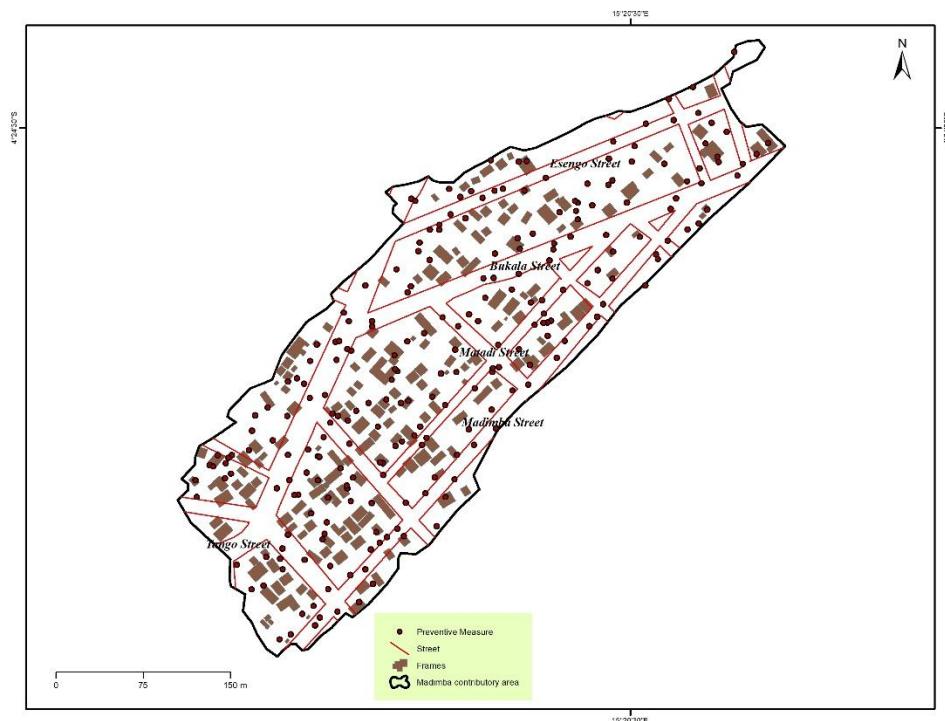
Fig.2c: Location of structures and measures for erosion control in the contributing areas of Madimba

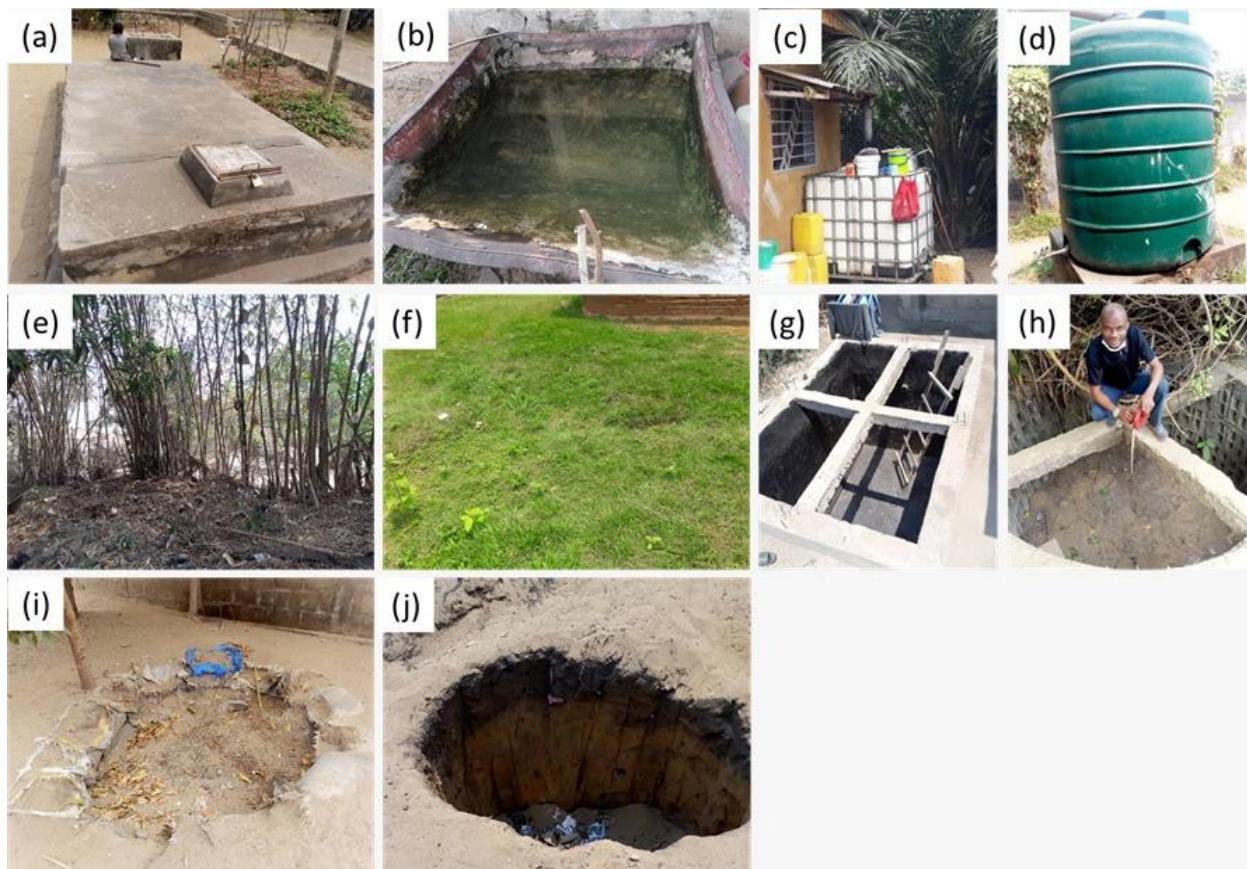
Fig. 3: Examples of runoff water retention measures observed for the collection, storage, and infiltration of rainwater. a and g: Sealed underground masonry tanks; b: Underground metal tank; c and d: Plastic rainwater tanks (small and large capacity); e and f: Vegetation enhancing infiltration rates and preventing bottom clogging; h: Soakaway pit with concrete blocks; i and j: Infiltration trenches.

The measures recorded in the field (Fig.3) are presented in the various tables and graphs below. Figure 4 and Table 2a & b show the preventive measures implemented in the Congo-Fort, EP5 Livulu, and Madimba zones. In the Madimba ZC, retention basins are the most frequently used, with 62 occurrences representing 25.6% of all identified measures. These are therefore the most commonly employed techniques, unfortunately also the least maintained. In total, 242 measures
